Slip Sliding Away

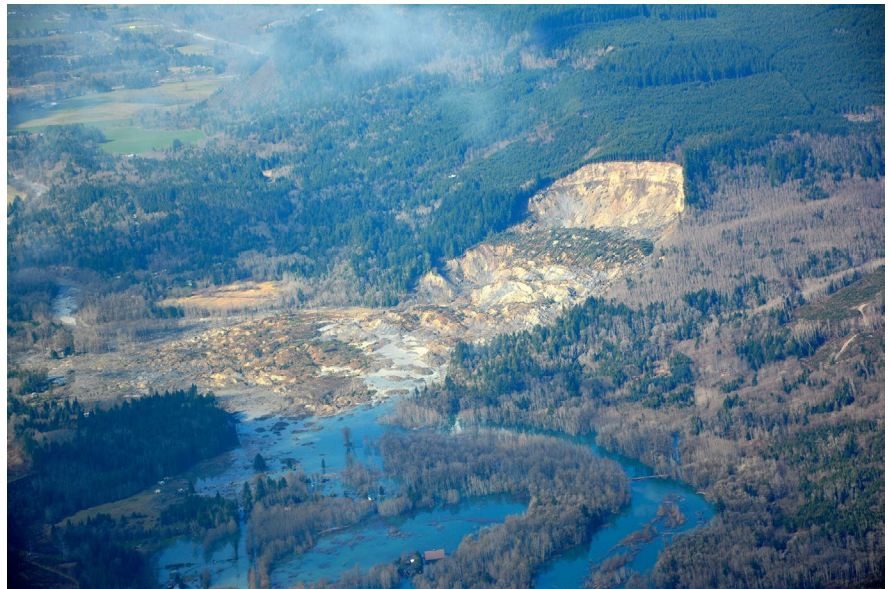
An aerial view of the Stillaguamish River and State Route 530 after the Oso landslide on March 22. The landslide resulted in the damming of the Stillaguamish River in Snohomish County. Mud covering the area, including SR 530, is a mile wide.

Oso experienced debris flow, the rapid movement of loose materials massed together as a slurry 9 to 21 feet deep. The weight of soil, rock, organic material, and extraordinary amount of water from heavy spring rains roaring downhill gave residents little opportunity to escape – this time. The slope area, known as the Hazel Landslide, has experienced lesser events due to instability documented back to 1937, most recently in 2006. A possible buyout of homes below it was tabled in 2004, and a

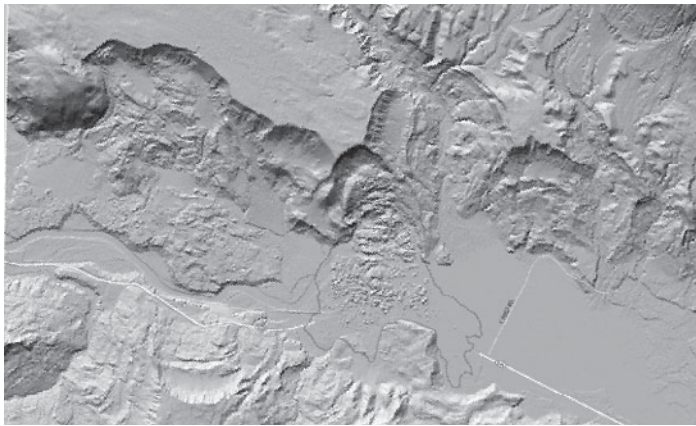
Lidar image showing the upper parts of the landslide that occurred in northwest Washington on March 22, 2014.
