By Jay Jones, PLS

Lessons Learned

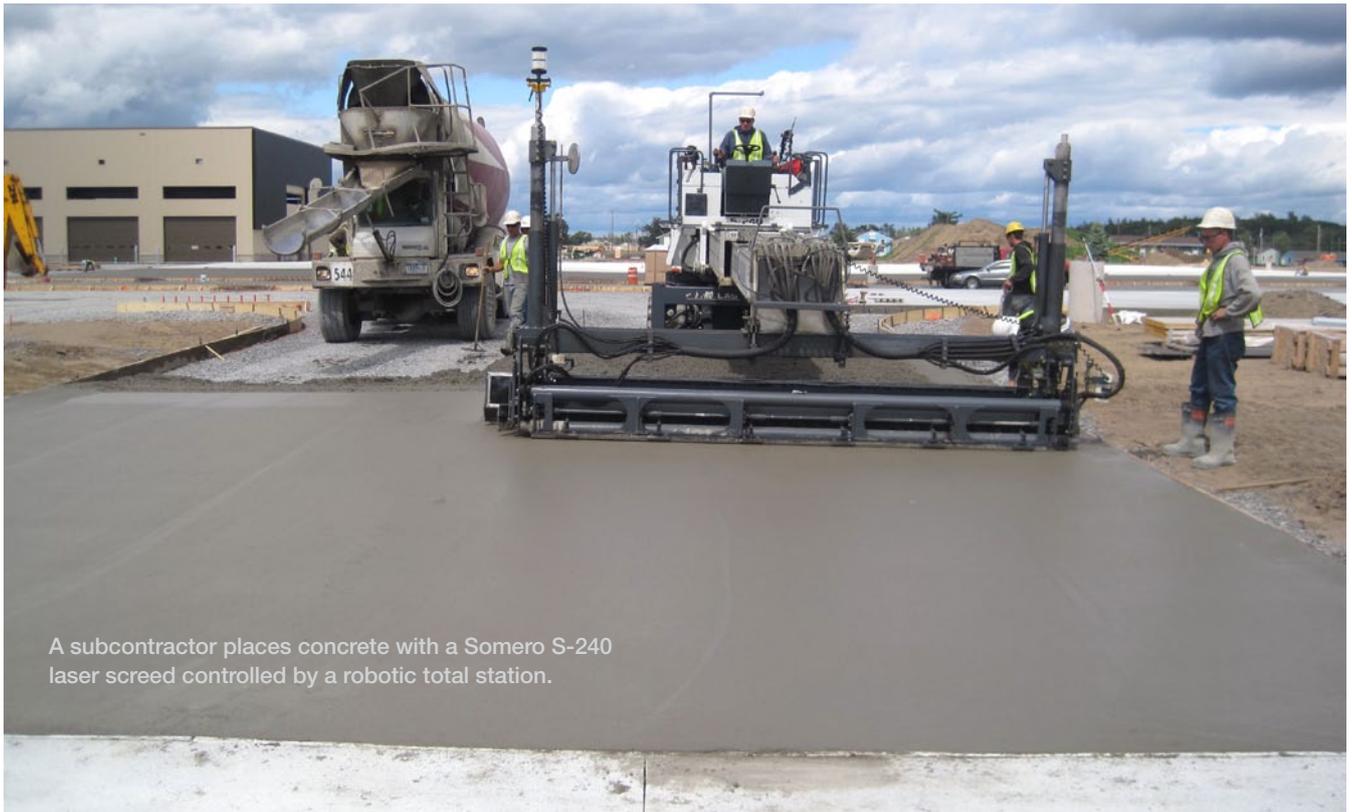
A subcontractor places concrete with a Somero S-240 laser screed controlled by a robotic total station.

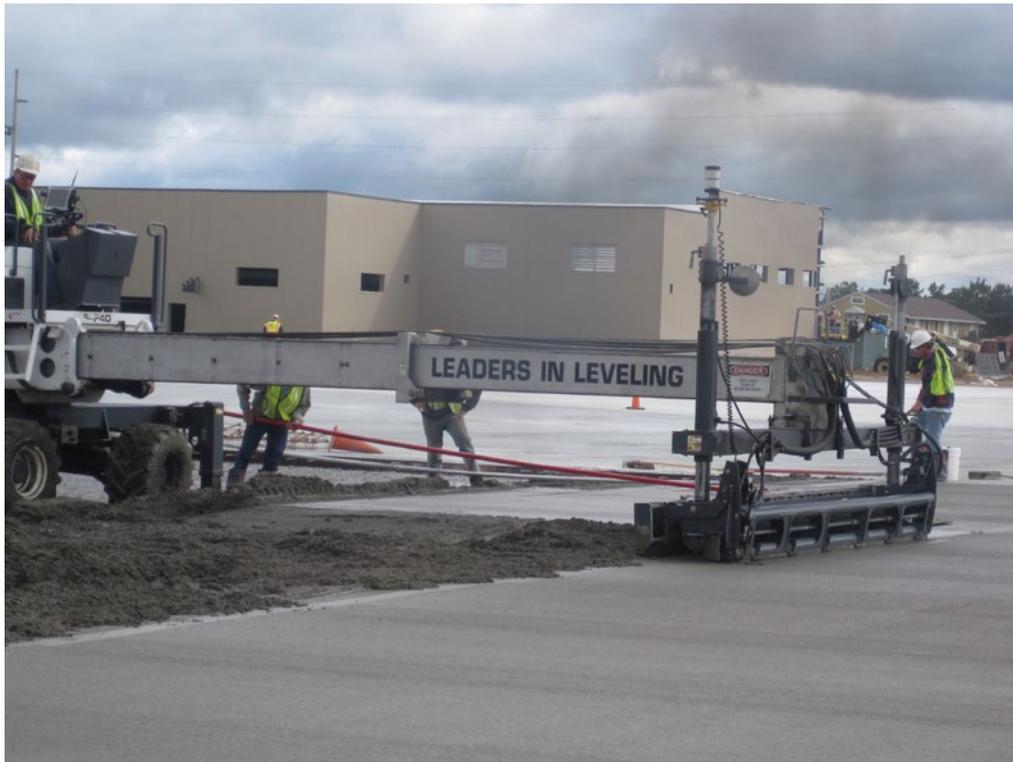
Left: The use of a machine controlled laser screed makes the placement of concrete quicker and more accurate.

Below: Machine control technology makes possible wider than normal concrete pours, eliminating intermediate forms but still meeting the drainage requirements.

However, with today's machine control technology, you can add a system to the laser screed that is controlled by a total station and it will use the total station information to determine the screed's location and grade and slope sensors to measure the slope of the screed board. The interesting part of this situation is that this system works with point information (northing, easting and elevation) instead of a surface model. In this case, the subcontractor needed the point information on the surface, so I created the necessary points on a 15-foot grid along all the concrete joints and was able to gain extra revenue for the project.

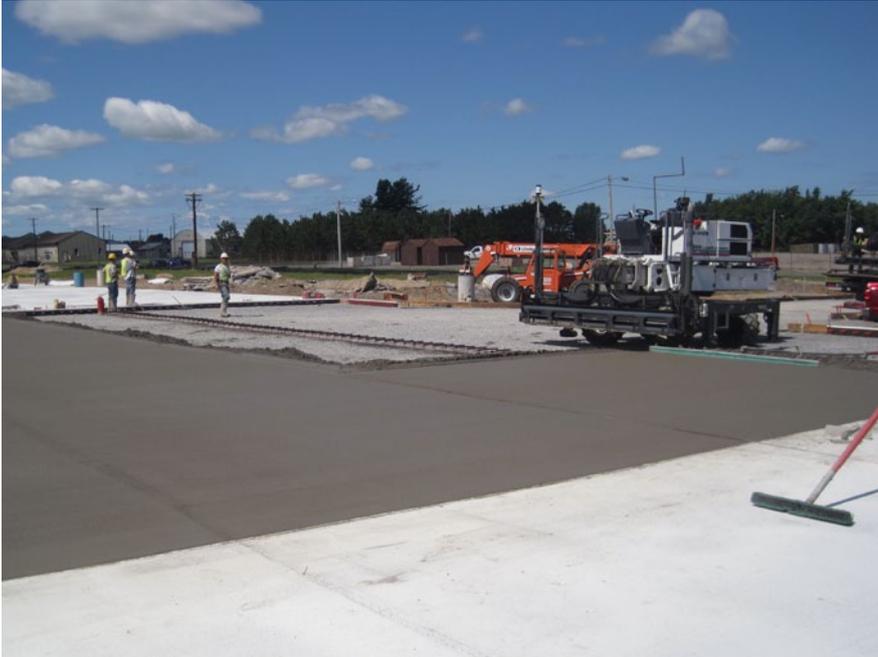
Machine control helps the concrete subcontractor to reduce the amount of excess quantities.
