Watch Where You Step

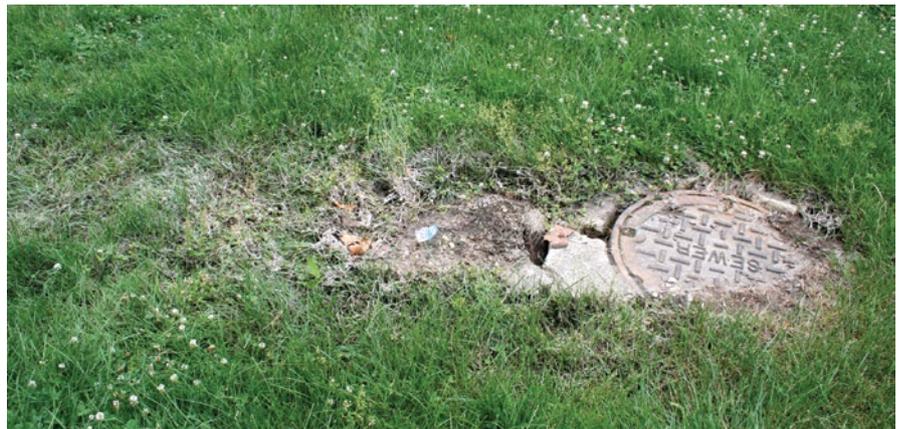
This sewer manhole has ruptured; its unvented lid dislodged during recent rains.

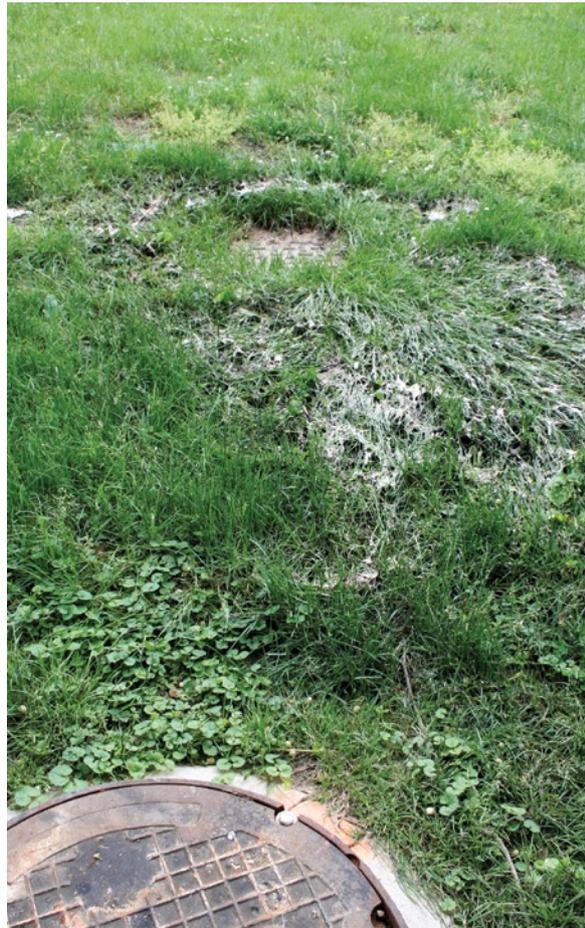
ply ruptures the pipes. Meanwhile, surface runoff can scour the soil so that there is no ground over the cracked piping. The result is what you see in the photos.

Here the pipes between manholes have ruptured, and the soils above them sank and eroded to form above-ground effluent pools. Overbank flooding from the nearby stream has "cleaned up" most of the initial stains.
